An Assessment of Riparian and Fish Habitat Health on Browns Gulch, Upper Clark Fork River Basin

Molly Staats and Will McDowell, Watershed Restoration Coalition (WRC)

DRAFT: 11 February, 2014

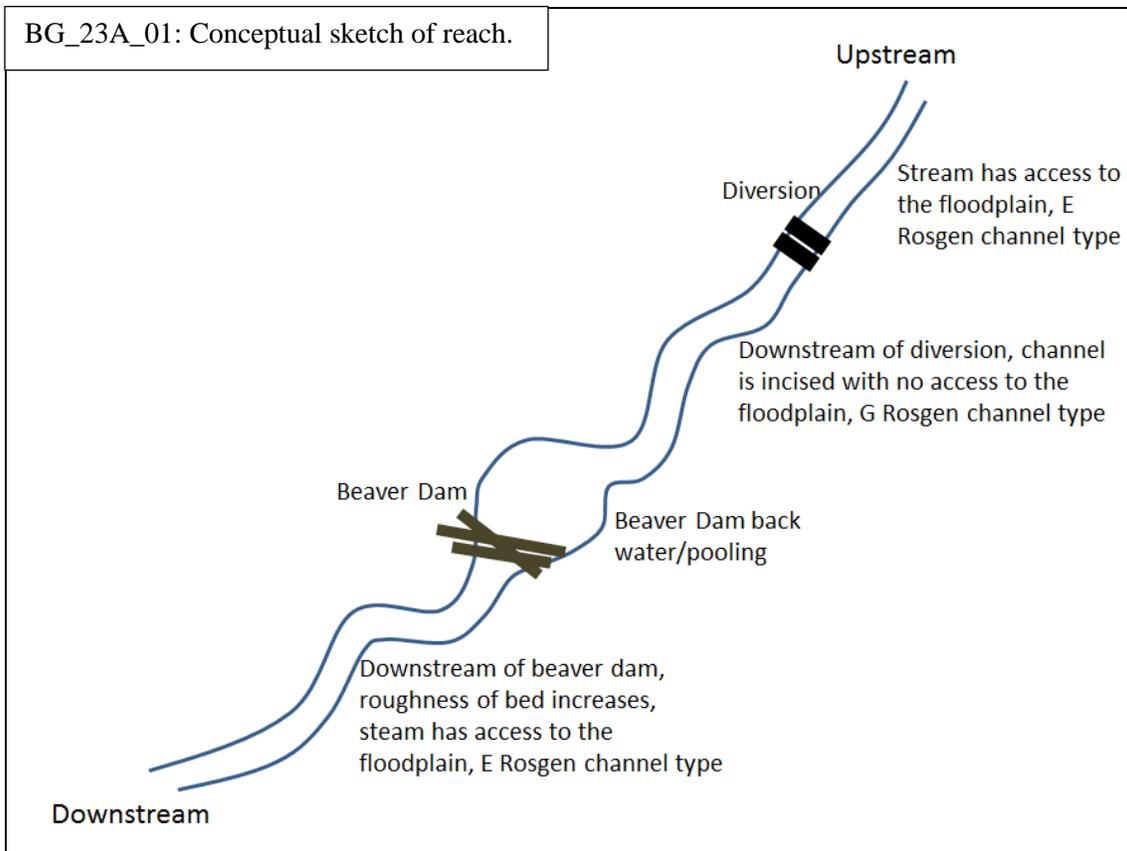
There are several problems noted within this sub-reach, mostly pertaining to the center of the reach. Firstly, there is historical/mechanical channel straightening, with rip-rapped/hardening of channel walls. The channel is attempting to regain its sinuosity from this straightening, which in turn is inducing incisement and lateral erosion. There is additional erosion from cattle trampling, crossing, hoof shear, and lack of deep-root binding riparian vegetation (both from browse and rubbing/physical impact). Furthermore, there appears to be water quality degradation issues such as excess fine-grained sediment and high nutrient load from cattle manure, along with evident low flows.

The issues discussed result in a NRCS score for this reach of 57%, “sustainable at risk” and a poor fish habitat score, evidenced by the low number of shallow pool habitat elements (very few deep pools), low substrate quality, moderate amounts of cover/shading (riparian vegetation and overhanging banks), and moderate percentage of large woody debris. There beaver dam located near the downstream end of the reach may act as a natural fish barrier during low flow months.

Potential restoration projects include improved grazing management, and further restoration assessments to explore renaturalization and/or grade control projects. Rewatering would benefit this reach, but potential for projects is low according to the assessment done by WRC in 2010.

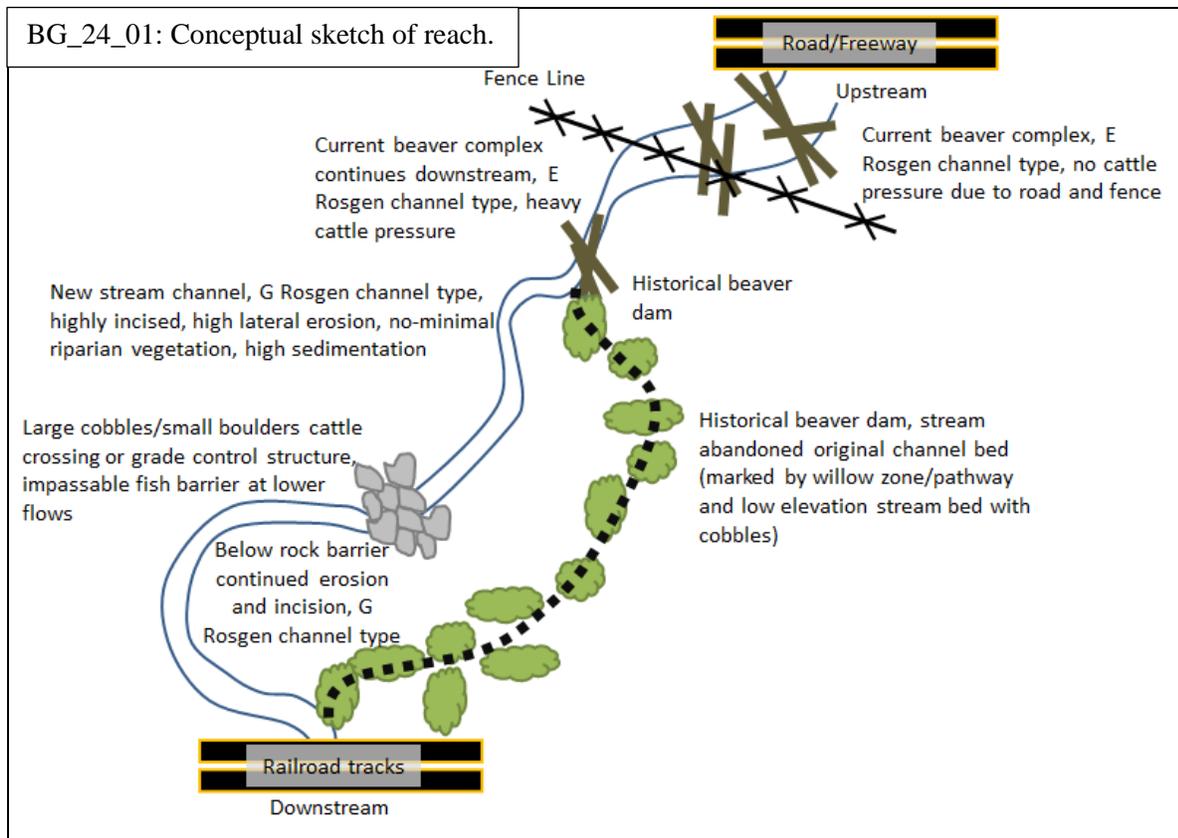
Density of woody riparian vegetation within this sub-reach is low and dominated by grasses with minimal willow and sedge (Nez Perce Code: SR2). There is intensive browse occurring via cattle, with no to minimal regeneration at this time, and a poor distribution of age classes of woody species (some mature and decadent willow). The primary problems noted within this sub-reach consist of the apparently natural beaver-caused channel avulsion, which is causing major erosion and incisement, and subsequent heavy livestock impact. This channel cannot stabilize within its new location due to cattle pressures, which further erode the stream banks and have halted any propagation of new deep-root binding riparian vegetation (via browse) that could strengthen the banks. This excessive bank erosion (measured at 10-30% of banks) is the primary cause for the high quantity of fine-grained sediment deposited on the stream bottom, which in places measures a foot in depth or more.

Additionally, a rock cattle crossing or grade control (gully plug) has been installed 2/3 of the way downstream within the reach in the last two years (Photo BG_24_07). It is comprised of large cobble and small boulders. The gully plug acts as a sieve for fine-grained sediment, resulting in a coarsening of bed substrate immediately downstream. The gully plug also acts as a fish barrier (water traveled under/through plug at time of assessment). There also appears to be nutrient water quality degradation issues, indicated by overgrowth of aquatic vascular plants and excessive algae on rocks. Other problems include minimal to moderate growth of noxious weeds like leafy spurge and thistle (species?).

The issues discussed above result in a NRCS score for this reach of 23%, unsustainable and poor fish habitat score, as evident in a moderate number of shallow to deep pool habitat elements, low substrate quality, minimal amounts of cover/shading due to overhanging banks and no shading from riparian vegetation. There is a low percentage of large woody debris.

There are two potential restoration project options. Option one is to relocate/reconstruct the channel into its original channel bed—it is likely that the original channel can be used for much of its length with little modification. A complementary measure is to improve grazing management. Trying to stabilize the existing avulsed channel in place will be quite difficult. Removal/re-design of the gully plug should be further investigated.
