Upper Browns Gulch

Riparian Restoration Project Profiles

26 September, 2014

By: Watershed Restoration Coalition

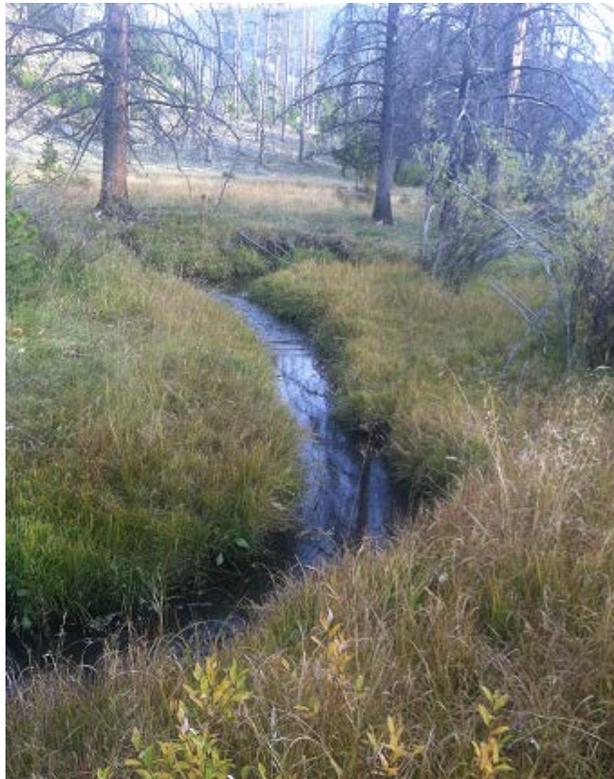
BG-00 Site with dead timber

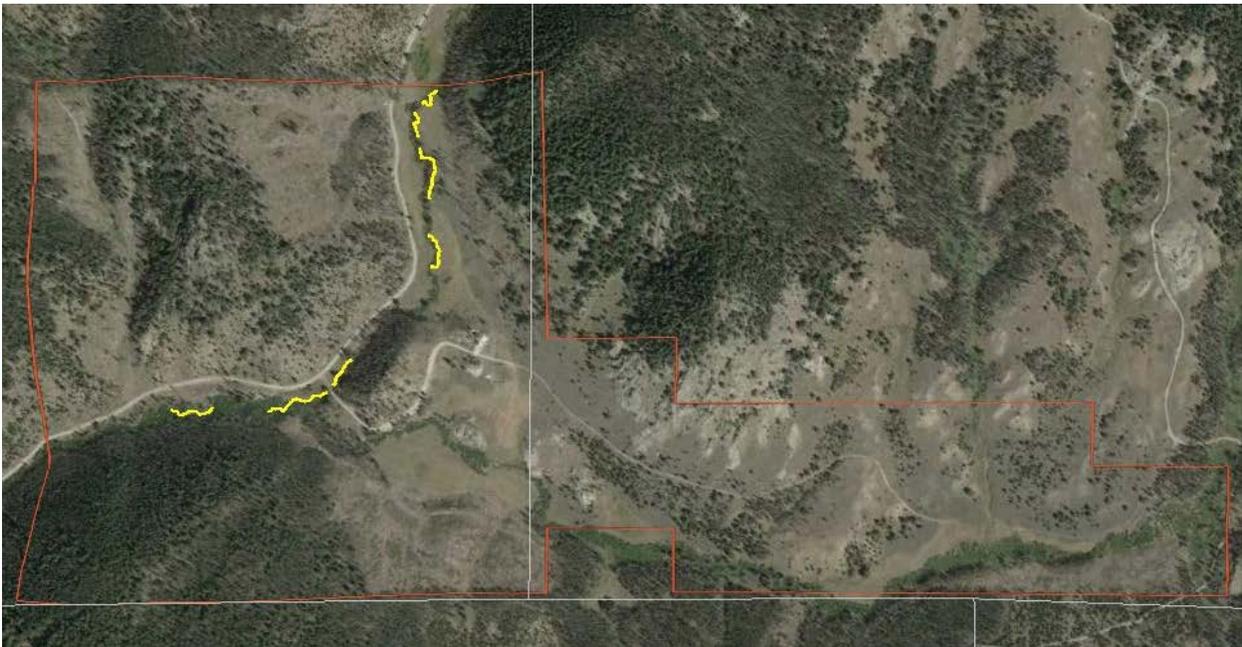
Map/diagram of Heavens Valley proposed LWD passive restoration reaches.

Yellow line denotes areas where LWD might be placed to promote passive restoration of banks. Property immediately upstream and downstream is USFS ownership.

*Type of Project: Riparian habitat restoration and protection through addition of large woody debris by directional felling of dead lodgepole pine over stream (passive restoration).	
*Landowner: Land Use: Summer grazing/recreation.	
*Location: Upper Browns Gulch at Lat. /Long. 46.1405, -112.5606	Assessment Status: Reach BG-00 scored 62% in NRCS-2013. Bank erosion in 2013 was 6% of reach.
<p>*Description of Project: The landowner is open to improving fish and riparian wildlife habitat while maintaining a small grazing lease, but does not want to cross-fence or riparian fence. Yet cattle impact on streambanks and vegetation needs to be addressed if fish habitat is to improve. Since the property has numerous beetle-killed lodgepole pine, an option is to place larger dead trees (LWD) in a criss-cross overlapping pattern above the stream and banks. This will provide physical exclusion of cattle from the stream banks and bed, and foster woody plant recovery, provide shade, cover and aquatic habitat complexity (as LWD deteriorates).</p> <p>This would be an experimental passive restoration strategy, one which was recommended by Steve Gerdes, the fish biologist on this Ranger District for many years. The work will need to be done by experienced tree fellers, facilitated by logging equipment, although some can be done by hand. Suitable material is available in many places very near the channel; in a few instance felled trees would need to be dragged (preferably in winter). Gaps in the LWD complexes will allow cattle and wildlife to easily move through the stream corridor.</p> <p>Activities: Felling and placing large trees along channel in a criss-cross pattern to protect banks and young vegetation from ungulates, as well as provide shade, cover for fishery.</p> <p>Distinctive Characteristics: Experimental low-cost passive habitat enhancement approach with a willing landowner. Reaches are adjacent to National Forest grazing allotments above and below this site, so if successful, the approach can be replicated and expanded on public land.</p> <p>Dimensions: Total of approximately 1700 ft. of streambank with 8-10 30ft. logs per 100 ft.</p>

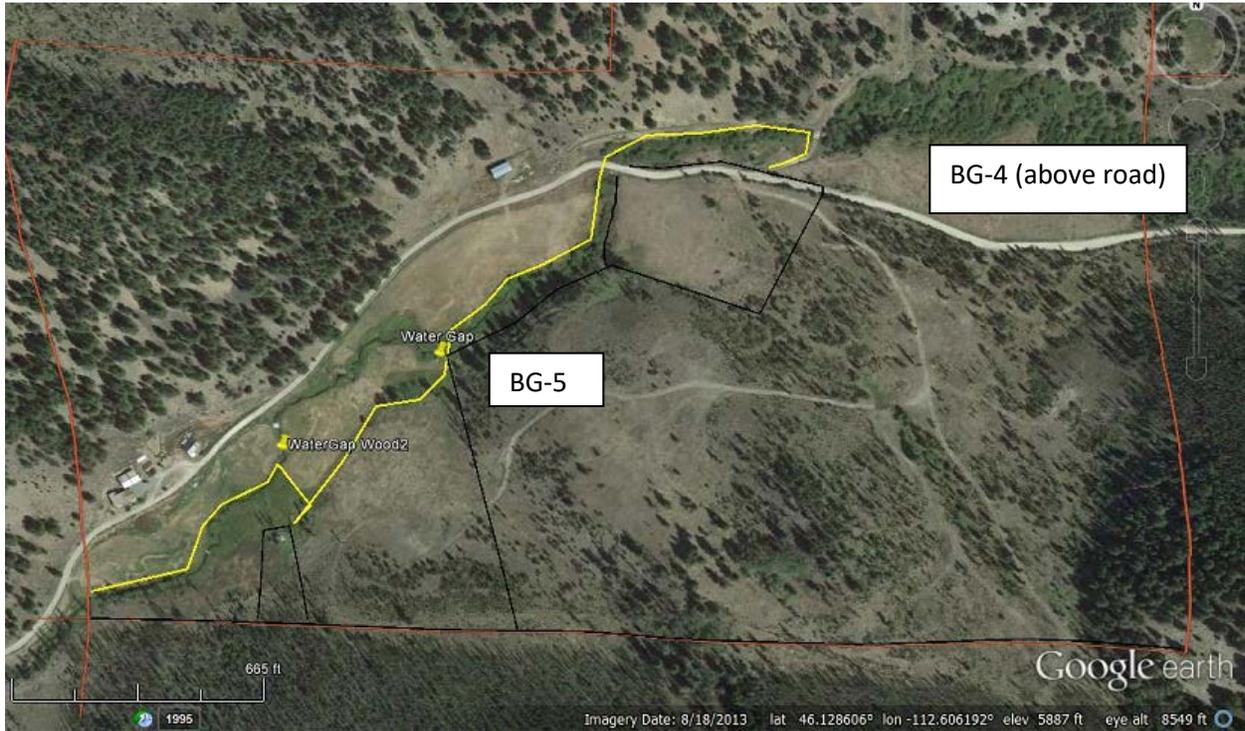
Map/diagram of Wood Ranch proposed riparian exclosures and water gaps:

Proposed fences in YELLOW. Existing fences are BLACK.

<p>*Type of Project: Riparian habitat restoration through grazing management in the riparian zone—use of riparian fencing and revegetation.</p>																
<p>*Landowner: <u>Grazing Leasee:</u></p>																
<p>*Location: Upper Browns Gulch Lat. /Long. 46.1280 -112.6094</p>	<p>Assessment Status: Reaches BG-4/5 scored 75, 52 in 2005. Bank erosion 4-5% in 2011. Poor woody veg in BG5</p>															
<p>*Description of Project:</p> <p><u>Activities:</u> Create two riparian exclosures below the road, and one above the road, that protect the Browns Gulch mainstem riparian corridor as it traverses a large hayfield (BG-5). The exclosures will be three-wire high-tensile electric fence with a solar charger. Two double water gaps (crossing-gaps) hardened with gravel-cobble will allow the livestock to drink, and to cross the stream in a designated area. Flood irrigated hay production and early fall aftermath grazing of cattle will continue. Current grazing pressure is light, but willows were physically removed in past, and sporadically present.</p> <p><u>Distinctive Characteristics:</u> One section of the creek will remain unfenced due to logistical issues, but there the riparian revegetation can be compared between fenced and unfenced sections. Exclosures also protect some springs and associated native vegetation. Grazing plan may allow sheep for weed control as necessary.</p> <p><u>Dimensions:</u> The upper exclosure protects 630 feet of channel and the lower exclosure protects 680 feet. The middle unprotected section is about 500 feet in length.</p>																
<p>*Specific Restoration Benefits/Connection to Limiting Factors: Improves native riparian woody vegetation cover in a reach which was stripped of woody plants historically, providing additional shade, bank stability, and riparian habitat.</p>																
<p>*Other Benefits, including landowner incentives: Landowners are supportive if grazing lease income not diminished. Provides crossing for cattle and hay machinery.</p>																
<p>*Next Steps in Project Development/Implementation: Design, detailed cost estimate, possible integration into EQIP contract grazing plan.</p>

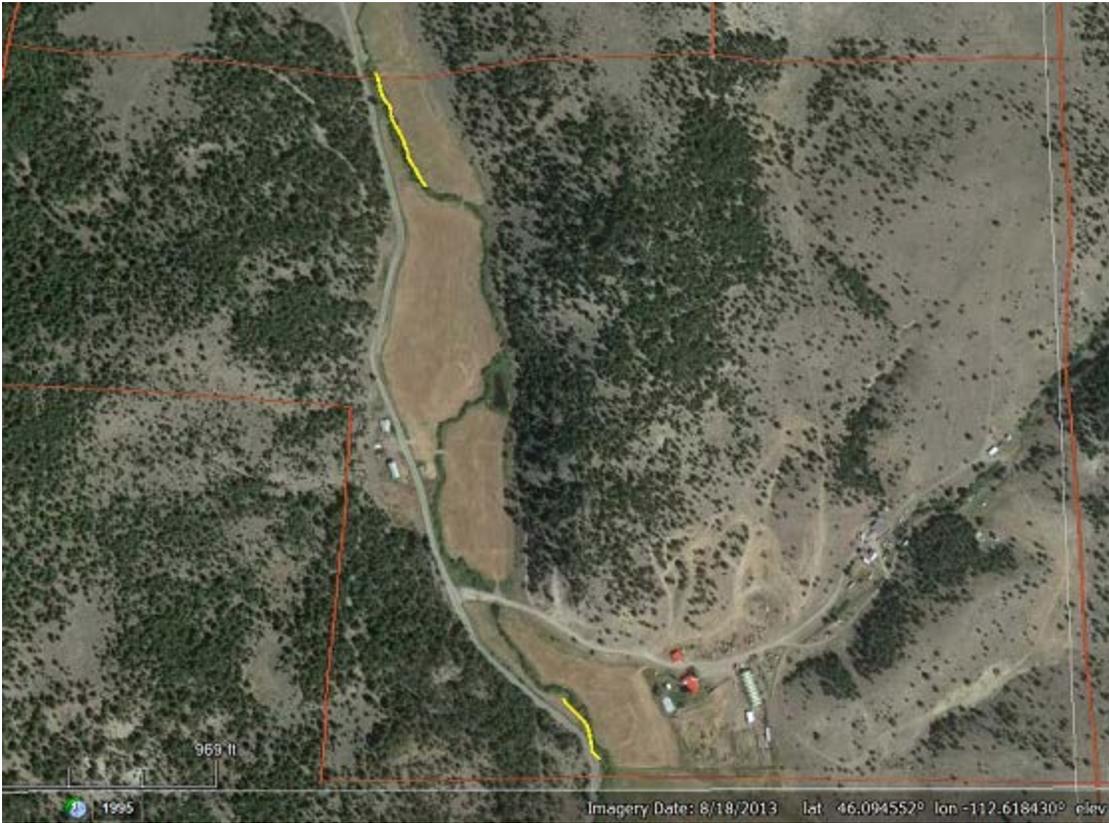
Map/diagram of Brothers Ranch proposed bank stabilization:

Yellow line denotes areas where landowner wishes to install rock toe to stabilize and revegetate banks.

<p>*Type of Project: Riparian habitat restoration and protection through stream bank stabilization/re-vegetation.</p>	
<p>*Landowner: Land Use: Grass hay, light grazing.</p>	
<p>*Location: Upper Browns Gulch at Lat. /Long. 46.0979, -112.62222</p>	<p>Assessment Status: Reach BG-12 scored 58% in NRCS-2005. Bank erosion in 2011 was 4% of reach.</p>
<p>*Description of Project: The landowner would like to reduce bank erosion and maintain a stable boundary between stream corridor and hayfield by doing some minor bank stabilization. This is a channelized reach, probably since the 1960s. The family formerly installed some small rock in the bank toe in much of the ranch to reduce under-cutting and channel meander. From their perspective, this has worked well, and habitat, though restricted to a narrow corridor, is not in bad shape given the situation. The rock toes are entirely overgrown with grass/sedges/willows, and barely noticeable. Some pools and runs exist. Willows, including many healthy mature specimens, have re-established in about 60% of the ranch's 0.66 mile-long reach, and are providing some bank stability, shade, and cover for the fishery. The channelized reach has evolved to a fairly stable state. Sites without rock toes, have continued to laterally erode into hayfields, through undercutting and caving. These are the sites where the landowner would like to install more rock toe (6"-10" rock, flat to angular) by peeling back sod, placing rock toes, then replacing sod and replanting willows.</p> <p>Activities: Construct 600 ft. of stabilized bank using rock toe and in situ sod, and re-vegetate with native willows.</p> <p>Distinctive Characteristics: Innovative landowner experience in bank stabilization with in situ sod for small-scale commercial agricultural land. Grazing is very light and does not appear to be major impact on the stream banks or willow community. Provides some habitat improvement where agriculture is destined to continue, and stream conservation corridor can not widen. Landowner would like to construct the project personally.</p> <p>Dimensions: The project would affect two reaches, one about 450 ft. in length at north end of property, and one of 150 ft. at south end. Coverage approximately 50% of banks where existing willows are not sufficient to stabilize banks.</p>
