Conceptual Restoration Design Lower Blacktail Creek

FINAL REPORT

Lower Blacktail Creek Project Area

January 2015

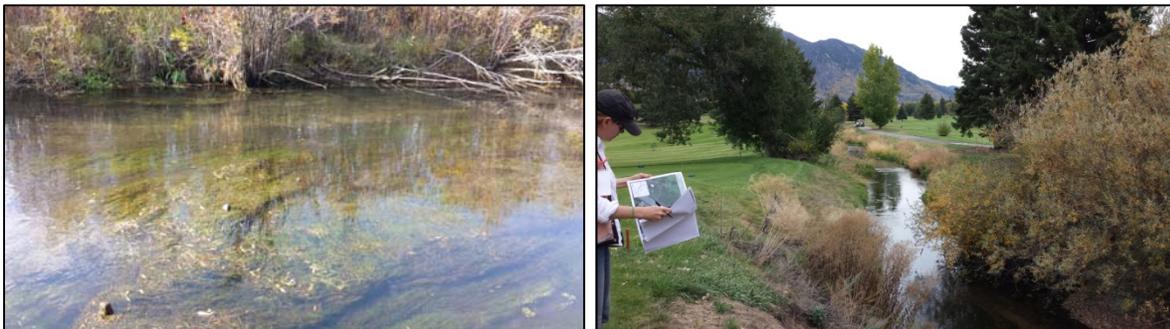
Figure 2-4. Typical aquatic habitat conditions in lower Blacktail Creek displaying poor substrate conditions and simplified aquatic habitat.

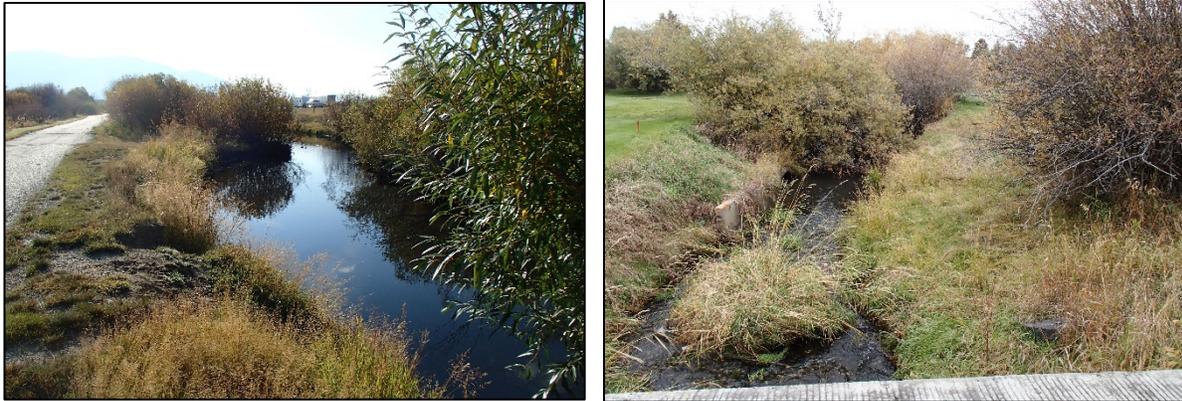
Figure 2-5. Typical conditions along lower Blacktail Creek displaying the narrow band of riparian vegetation.

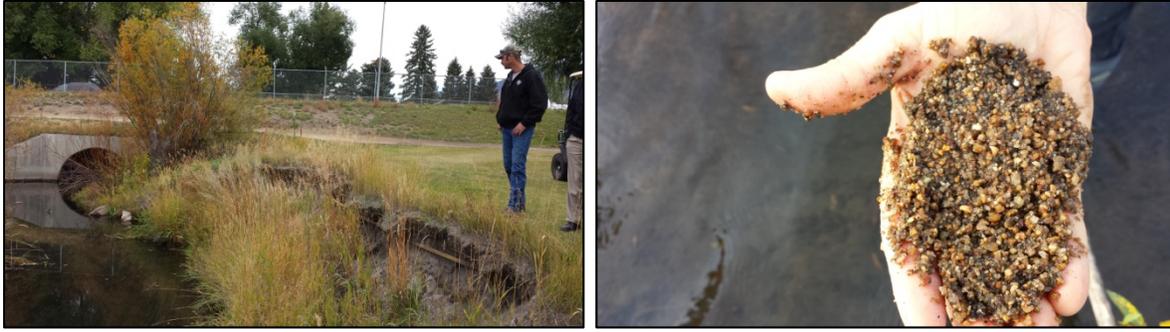
Figure 2-7. Bank erosion in lower Blacktail Creek is causing damage to infrastructure and embedding gravel substrate with sand.

Bank erosion: Blacktail Creek is responding to altered channel morphology and vegetation conditions. Steep, sparsely vegetated banks composed of fine grained soils are susceptible to bank erosion as Blacktail Creek attempts to establish equilibrium in its altered landscape. Bank erosion delivers fine sediment to the channel bed and causes damage to private property along the creek.

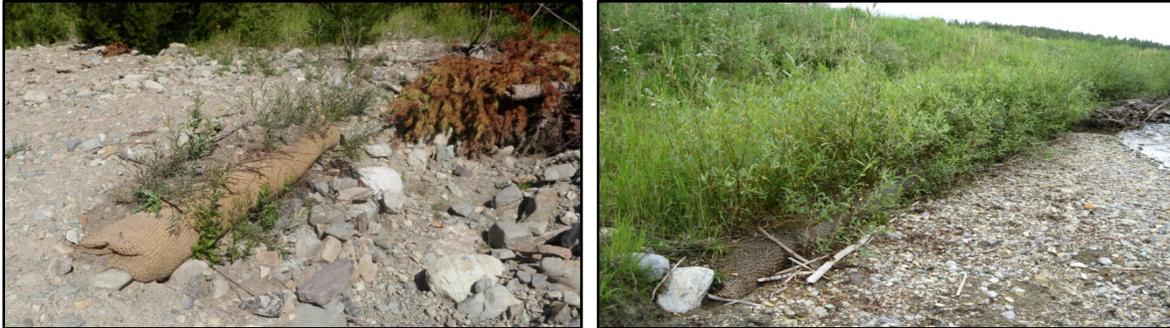
Figure 4-2. Example photographs of bioengineering streambank structures.

Bioengineering is a category of streambank treatments consisting of live plant material and biodegradable coconut fiber fabrics (coir). Bioengineering treatments create bank conditions that support the establishment of woody vegetation. Figure 4-1 shows a conceptual cross section of a typical bioengineering streambank treatment called a vegetated soil lift. Figure 4-2 shows example photos of bioengineering streambank structures.

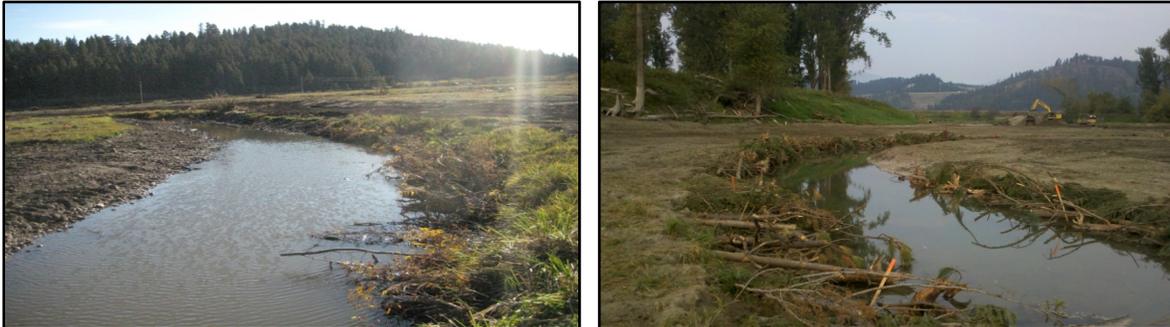
Figure 4-4. Examples of fascine streambank structures.

Figure 4-4 shows example photos of a fascine streambank structures.

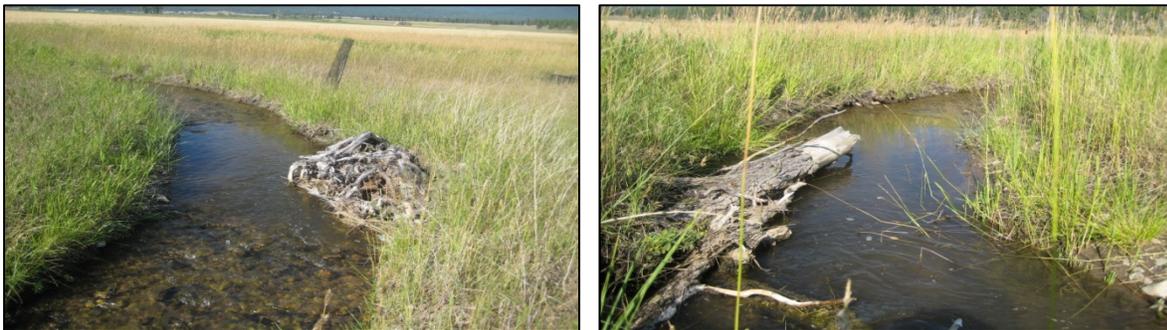
Figure 4-6. Examples of woody debris jams.

Woody debris jams are a category of streambank structures consisting of logs and brush buried into the streambank and projecting out into the channel. Woody debris jams are intended to emulate natural accumulations of woody debris along the bank margins. Figure 4-5 shows a conceptual cross section view of a woody debris jam structure. Figure 4-6 shows example photos of small woody debris jams.

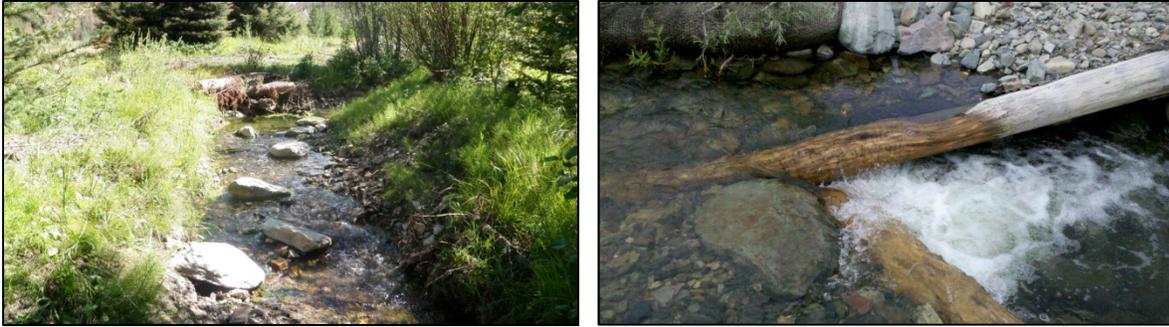
Figure 4-7. Examples of aquatic habitat enhancement structures including boulder clusters and log weirs.

Aquatic habitat enhancement structures are a category of streambank and channel structures used to address aquatic habitat limiting factors. Aquatic habitat enhancement treatments can be used to create hydraulic complexity, establish cover, alter substrate conditions or promote pool development. Structures are typically constructed from native materials including logs, brush, clump transplants and boulders. Types of aquatic habitat enhancement structures include log weirs, log vanes, boulder clusters and various other configurations using native materials. Figure 4-7 contains example photographs of habitat enhancement structures.

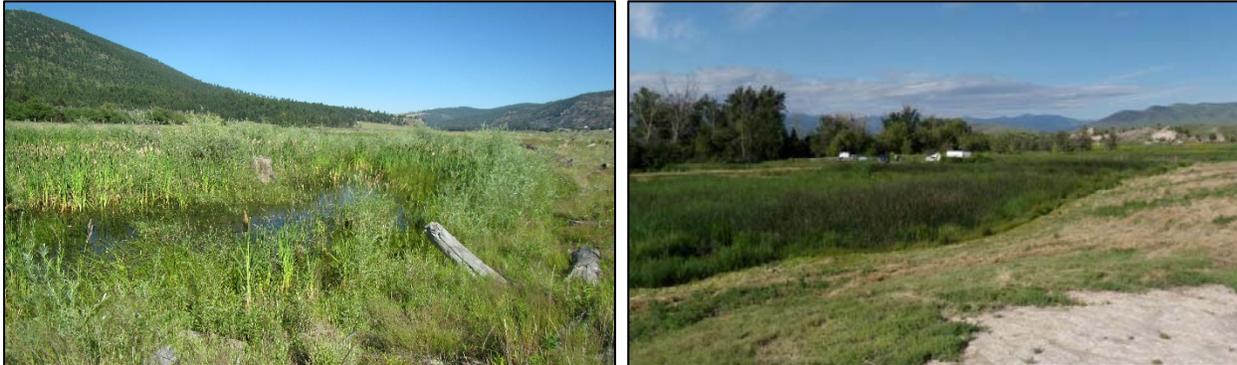
Figure 4-8. Examples of constructed wetlands in floodplains (photo left) and constructed for treatment of high levels of nutrients (photo right).

or rain events. Exact design criteria for treatment wetlands should be developed during the design process and determined by the specific pollutants to be treated.

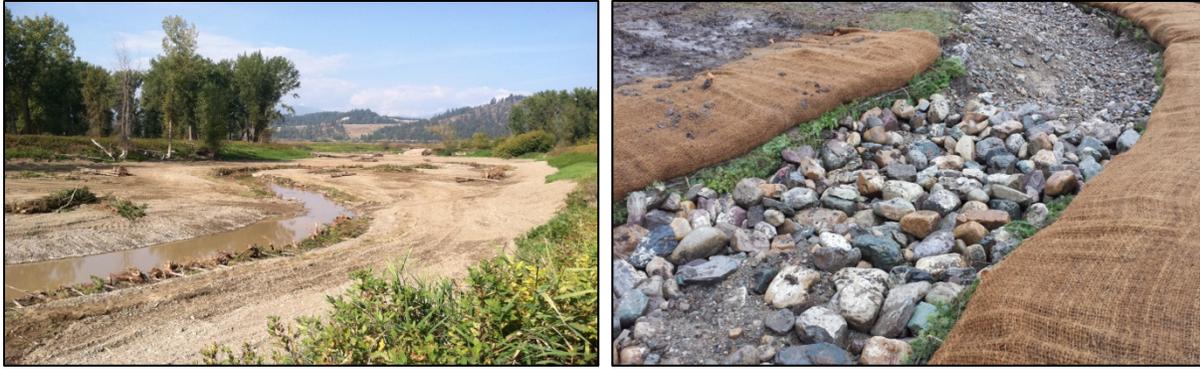
Figure 4-9. Examples of channel reconstruction (photo left) and pool-riffle sequences (photo right).

Channel reconstruction may also include reconstruction of the stream bed, whereby riffles are built from imported streambed material. Riffle construction can provide vertical streambed stability in new channel segments. In addition, riffle construction can introduce appropriate spawning substrate for focal aquatic species.

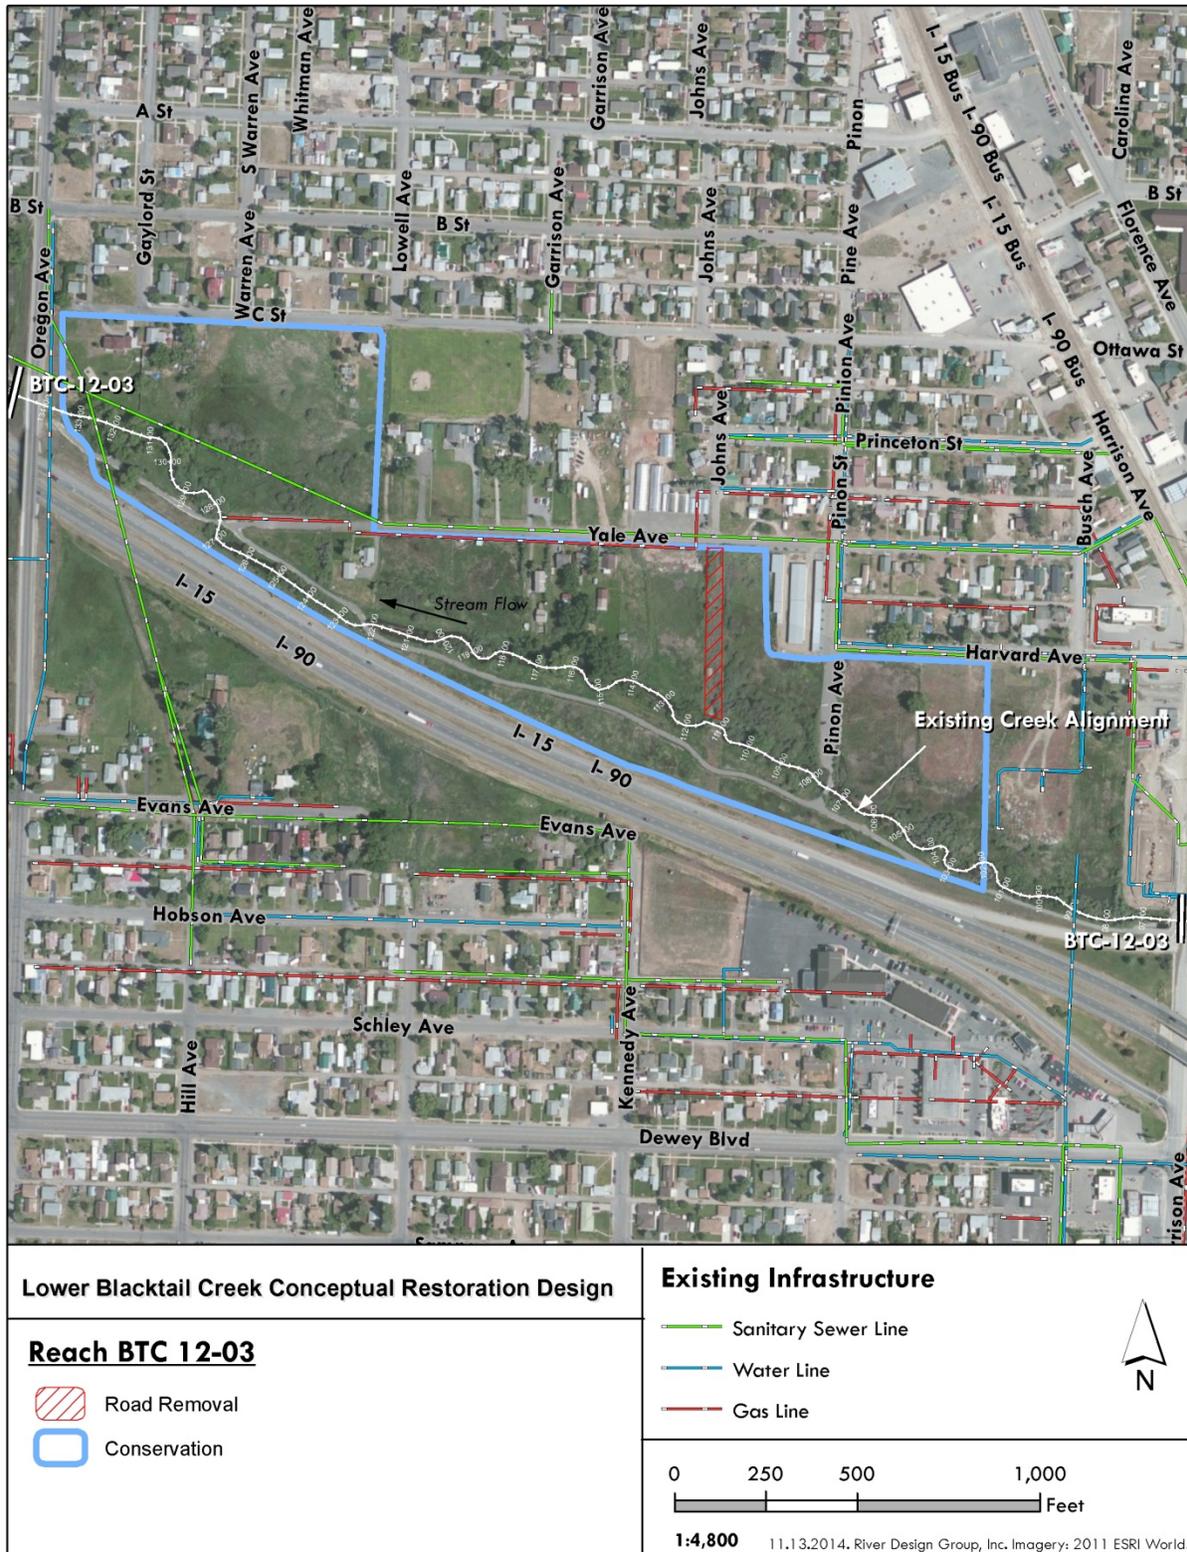
Figure 5-8. Restoration concept for Reach BTC-12-03.

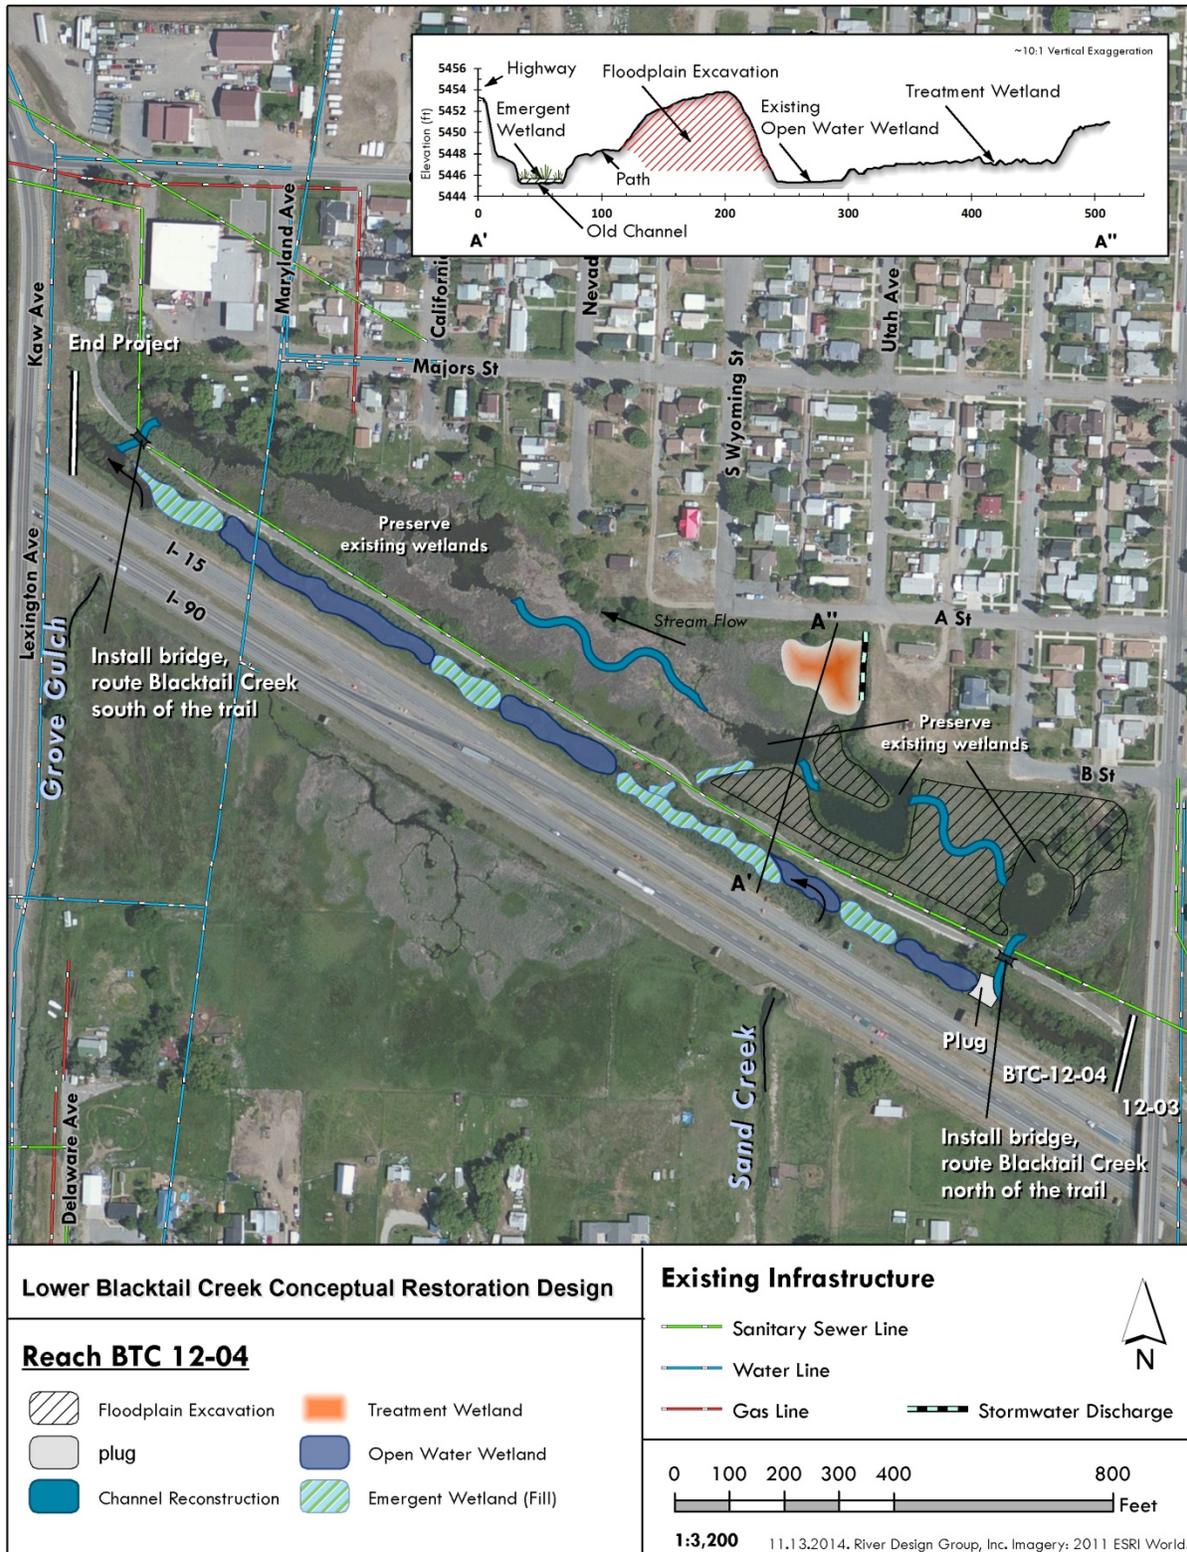
Figure 5-9. Restoration concept for Reach BTC-12-04.

The restoration concept for Reach BTC-12-04 is a comprehensive action encompassing all of the restoration strategies identified in Section 4. Floodplain excavation would remove elevated fills in the floodplain and expand the floodplain width. Channel reconstruction would reduce the channel width-depth ratio, increase pool frequency and improve habitat complexity. Streambank structures composed of woody vegetation and native materials would provide bank stability and improve streambank cover. Revegetation treatments would expand the riparian buffer and reduce invasive plant species. Wetlands would address water quality by intercepting stormwater runoff and capturing fine sediment. The reach would be placed in a conservation easement to provide long term protection of restoration efforts. The restoration concept for Reach BTC-12-04 is presented in Figure 5-9.

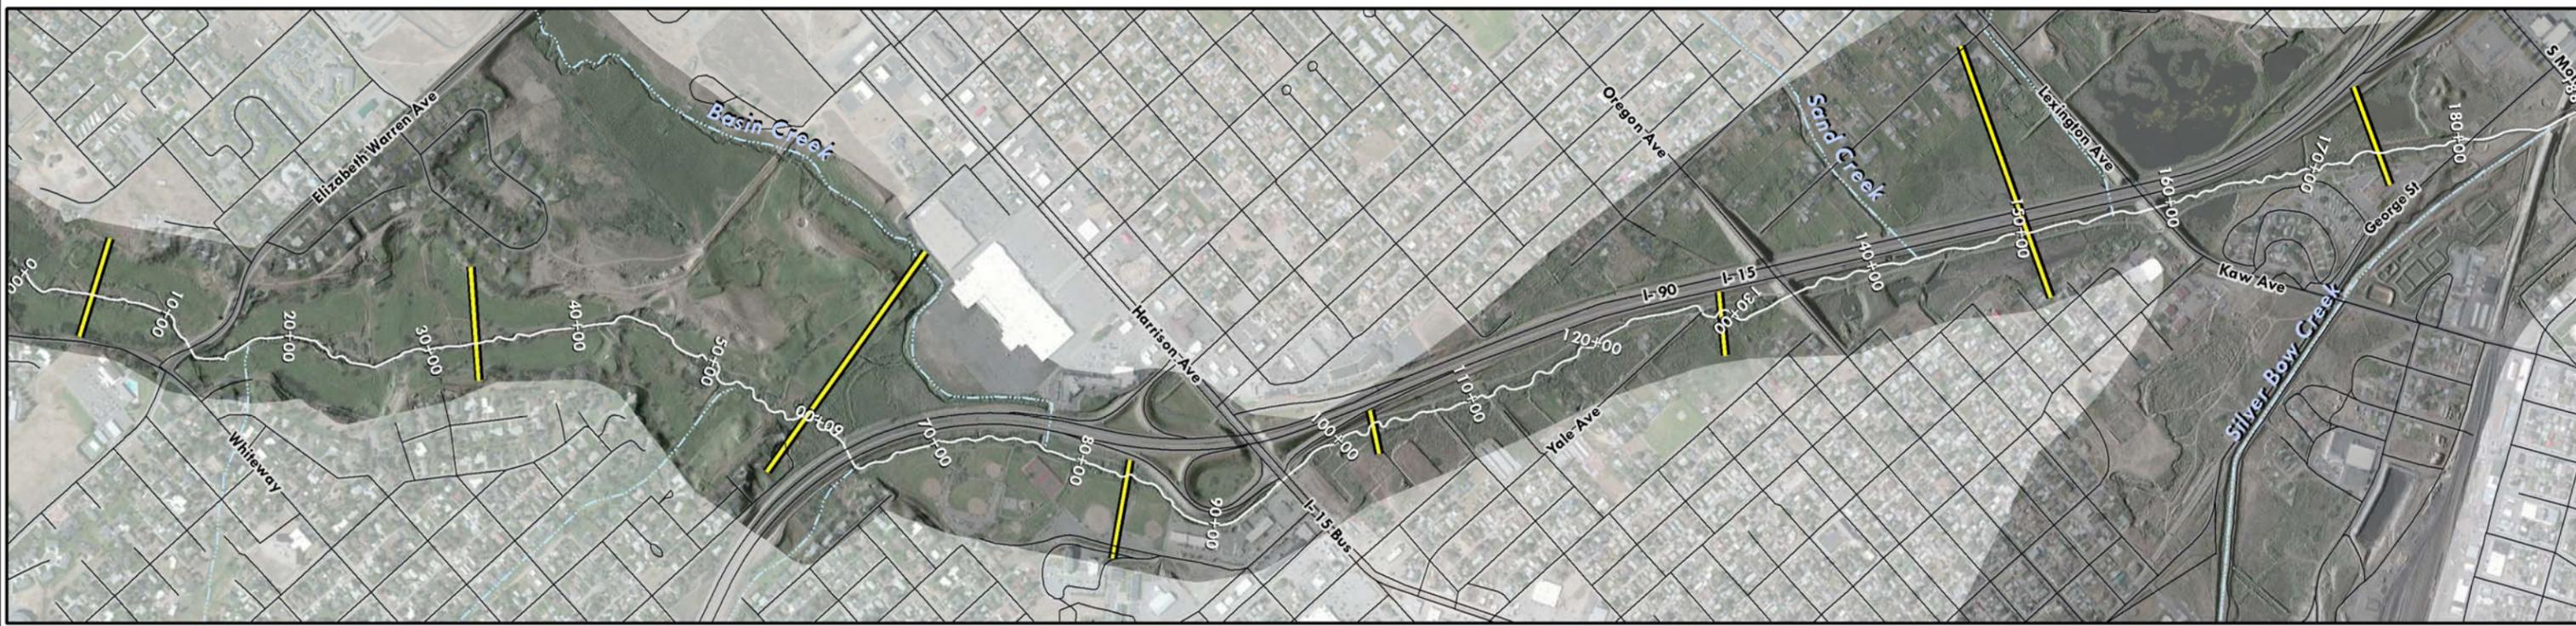
Lower Blacktail Creek Conceptual Restoration Design Longitudinal Profile	FEATURES Project Stationing (feet) Intermittent Stream Road			09.10.2014. River Design Group, Inc. Data: USGS NHD; 2013 TIGER. Imagery: 07.12.2011 ESRI World.	LP
	1 inch = 1,000 feet

Additional supporting information for geomorphic limiting factors is provided in Appendix C, which contains a longitudinal profile and cross sections developed from LiDAR data.

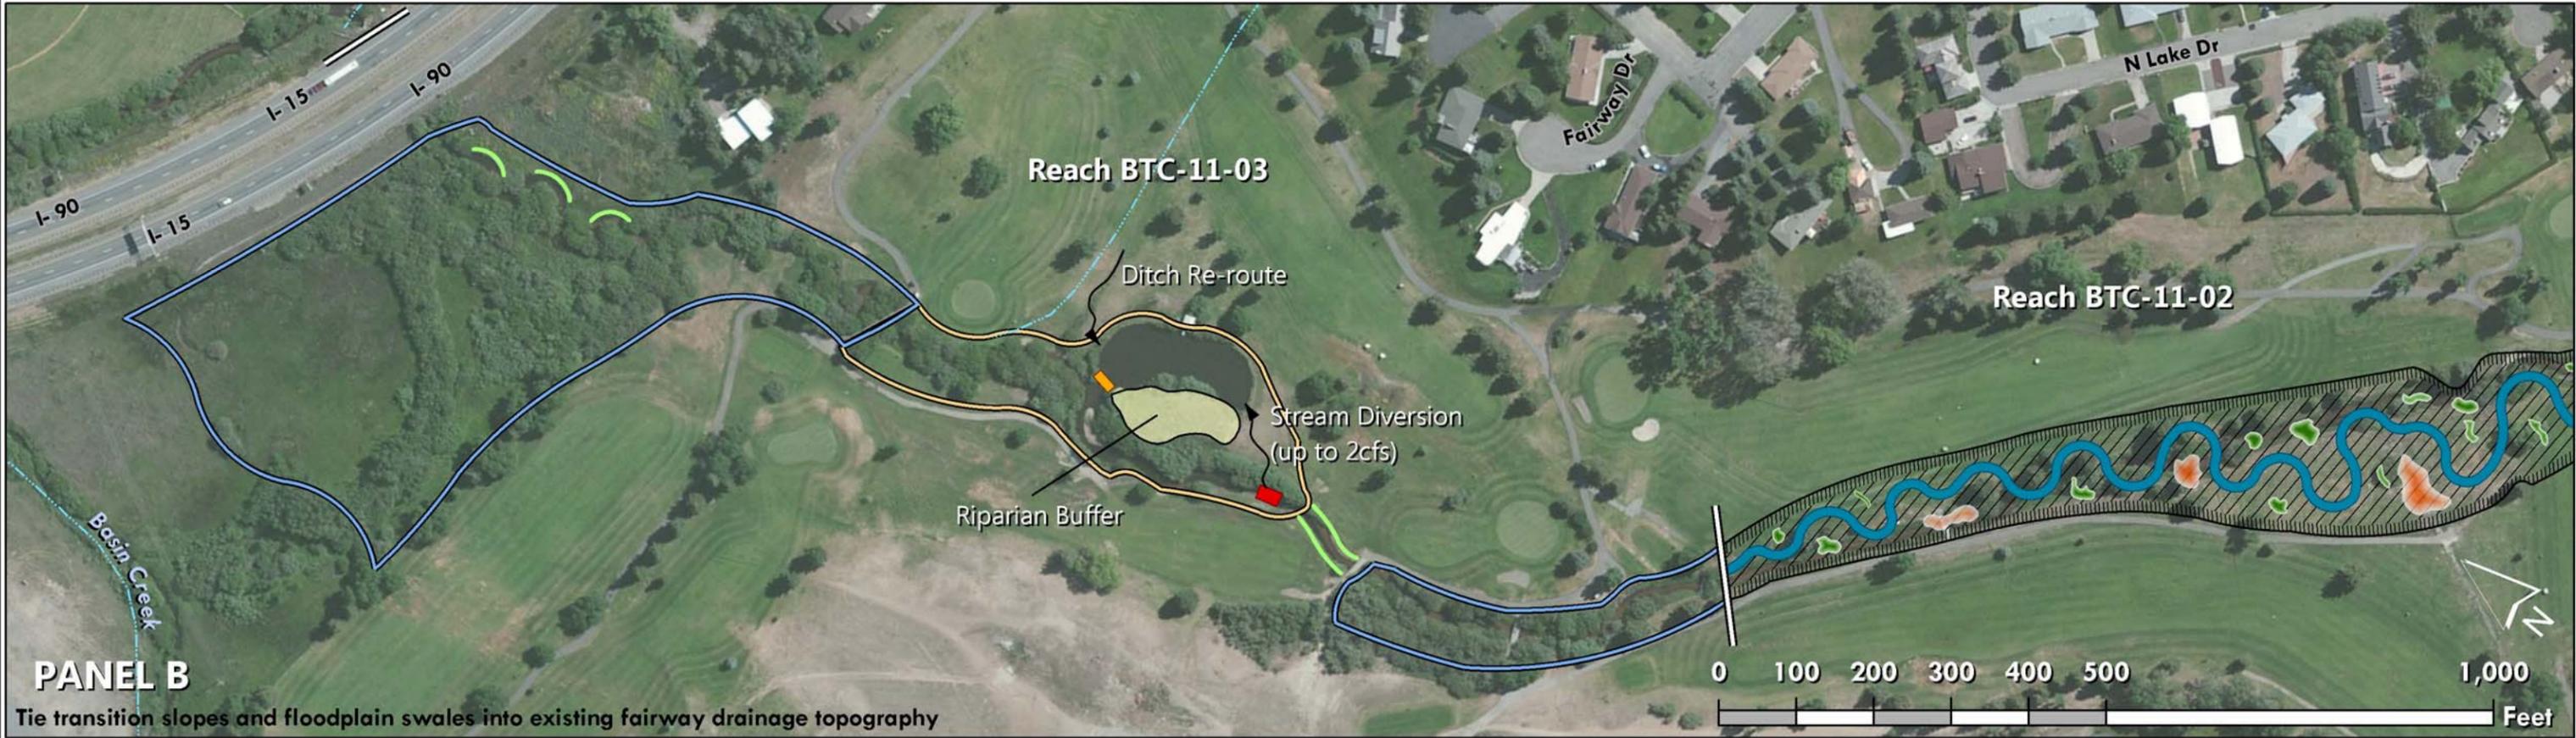
Lower Blacktail Creek Conceptual Restoration Design
Reach 11 Design

Features	
Floodplain Excavation	Transition Slope
Channel Reconstruction	Floodplain Surface
Floodplain Swale	Streambank Structure
Treatment Wetland	Floodplain Wetland
Revegetation Area	Diversion and Fish Screen
Conservation Area	Pond Outlet Control
Boulder/Log Weir	Intermittent Stream

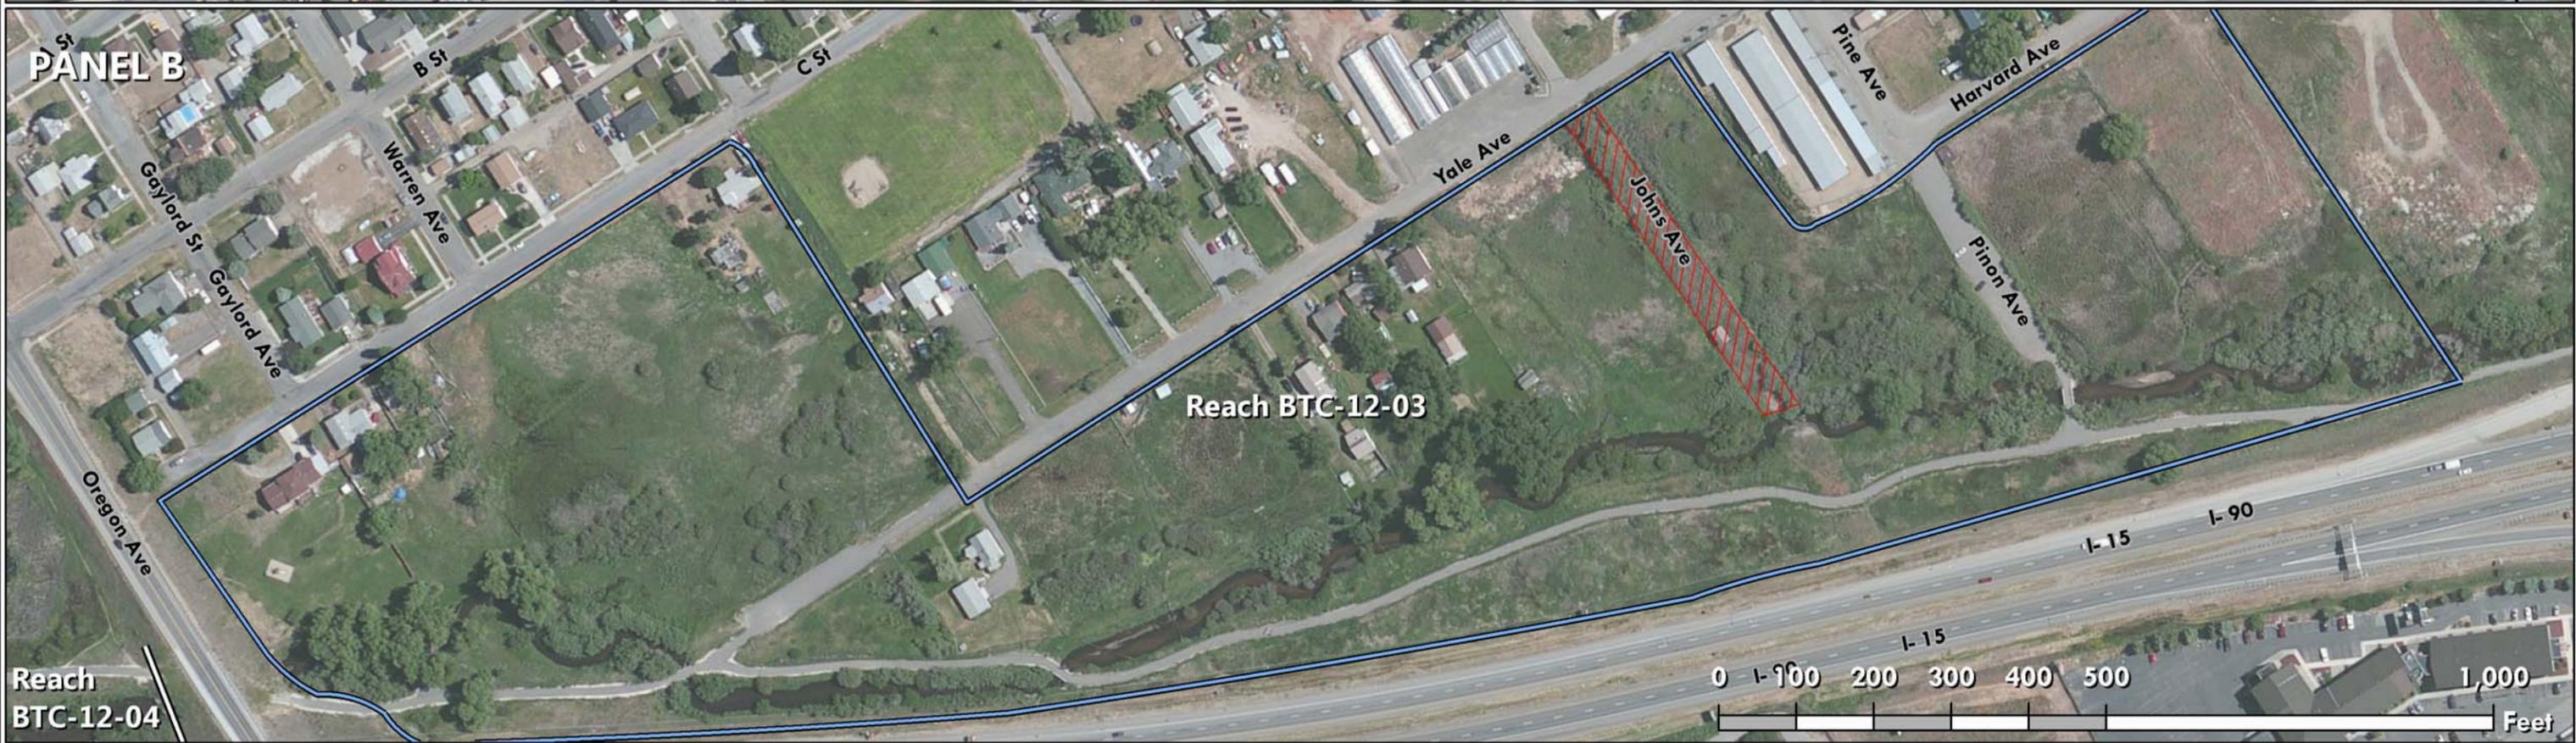
Lower Blacktail Creek Conceptual Restoration Design Reach 12 Design	Features Conservation Area Intermittent Stream Road Removal Sub-Reach Break		 1 inch = 200 feet	11.14.2014, River Design Group, Inc. Data: USGS NHD; 2013 TIGER Line Data; Imagery: 07.12.2011 ESRI World.	12A
